## Methods and Benefits of Spincasting Cements on Corrugated Metal Pipes

By Kurt W. Koehn, C. K. Masonry Company, Inc., Nashville, TN

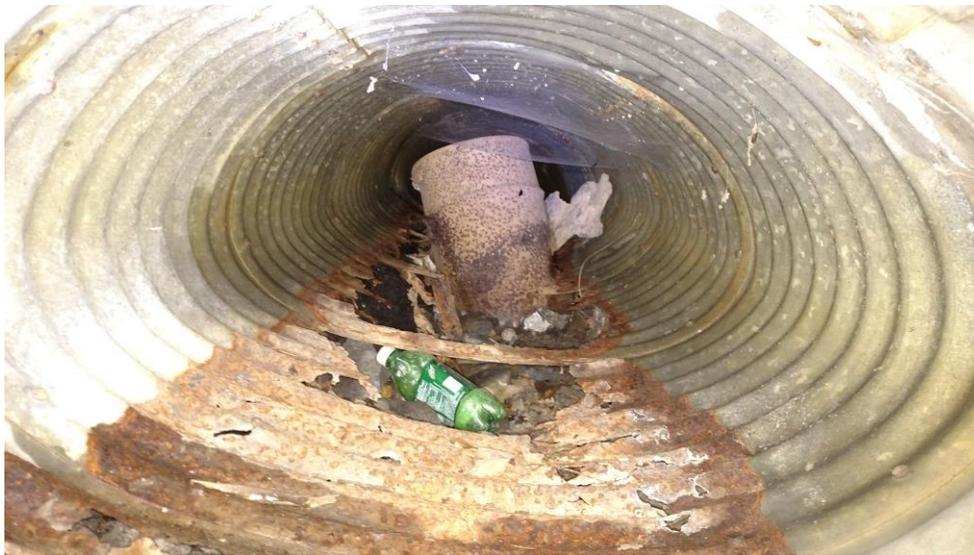
The need for repairs or replacement of storm pipe is well illustrated with corrugated metal pipes (CMP). CMP is used extensively throughout the United States with benefits including low material costs, relative lighter weight, and fewer joints than the popular alternative reinforced concrete pipe (RCP). That's the good news. The bad news is, based on numerous State Highway Department and various engineering agency studies, galvanized CMP has a 10 to 35 year life span before perforation<sup>1</sup>. Empirical observation suggests that rusted inverts are the most common cause of perforation. Once the inverts fail, undercutting occurs and the loading above the CMP causes the CMP to shift and sag. Pipe deflections and gaps in joints are sometimes observed. Ultimately, erosion begins to occur. When the CMP is placed under a street or highway, roadbed failure follows and/or potholes appear. At this point, repair or replace operations become critically necessary.

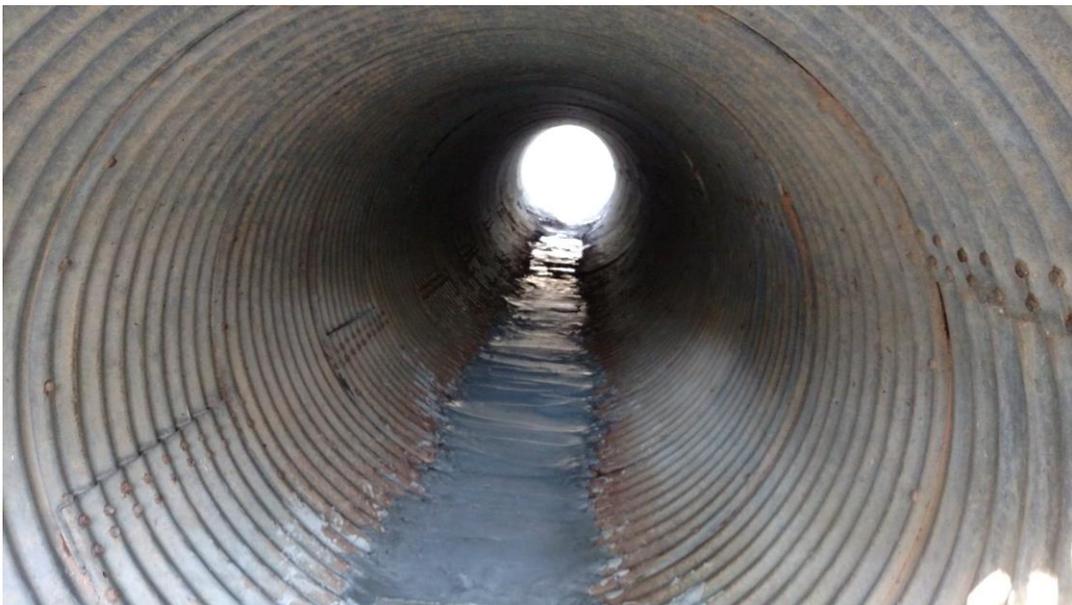
Once the pipe is properly cleaned, then invert degradation, pipe deflections, and joint offsets may be analyzed, either with man entry or with a sewer inspection camera. It is most important to repair the CMP invert first. Flowable grouts may be used with special pumps and hoses to pump the grout into, under, and around compromised or missing CMP inverts. The Strong Company Grout 12,000 is a 12,000 psi compressive strength grout that has excellent flow characteristics. Once Strong Grout 12,000 has been placed, the CMP invert bottom is re-established and incorporated into the high strength grout while undercutting is eliminated.

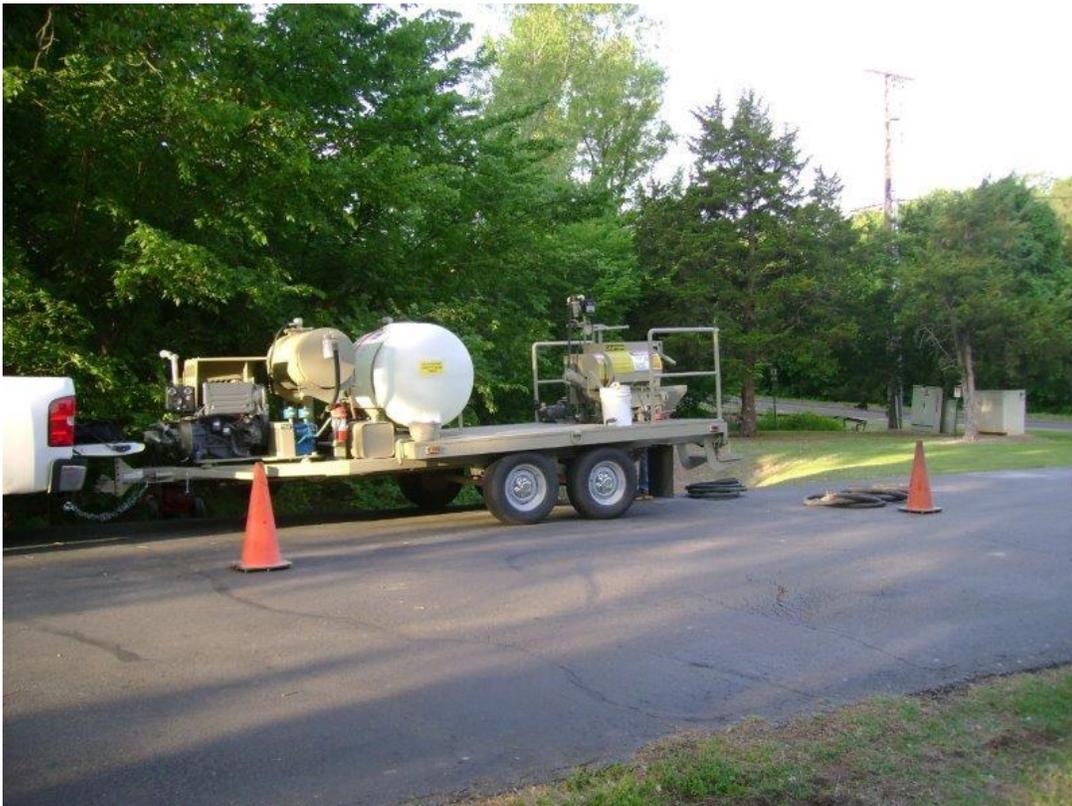
Once the pipe is cleaned, the invert repaired, joints sealed, and point deflections addressed, the CMP is ready for the lining operation using a spincaster and engineered high strength cements. The Strong Company's fiber-reinforced, 9,000 psi compressive strength Storm Seal Mix is specially designed to pump through a spincaster down to 12" with the use of a cement spray rig that incorporates a diesel power plant, hydraulic pumps, water tank, counter-rotating mixer, hopper, rotor/stator pump, electrical panel, variable speed winch, and spincaster.

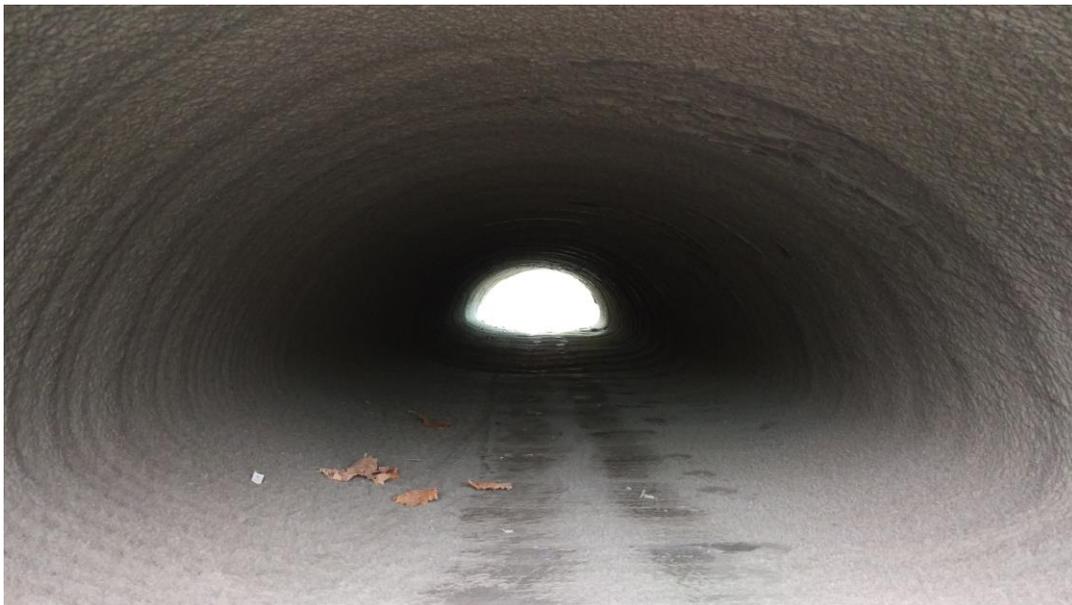
spincaster and the spincaster is pulled back to the rig at a predefined speed. In theory, the materials can be sprayed up 1" per pass and more. In practice, it is best to apply the materials to ensure excellent bonding to the substrate. Especially at the crown of the CMP, mortar weight can pull the mortar away from the substrate if applied too heavily. After applying a coat, the cements will need 2 to 3 hours to tack up before applying a second coating. The size and shape of the pipe and the desired thickness of the engineered cements will determine the number of passes made at a certain application rate. Usually, filling the CMP webbing and applying another ½" to 1" of the high strength Storm Seal Mix will be sufficient to rehabilitate the CMP to a point where it may actually outperform dig and replacement solutions. For reasonably round pipes, three to four passes will fill the webbing and add 1" of the Storm Seal Mix lining to the CMP. For elliptically shaped CMP, it is best to apply the mix at a rate that does not cause the material to sag on the minor axis so that axis becomes the axis that defines the rate that the material is applied. However, additional passes most likely will be required as the major axis will need more passes to gain the required thickness. Once the required number of passes are completed, it is best-practices to spray a concrete sealer on the liner to retard water loss while the cement cures. Once accomplished, the rehabilitated pipe liner will be structural, monolithic (no joints), hydraulically improved, and chemically resistant.
